Blue Ridge Associates, Inc.

**SITE CHARACTERIZATION REPORT
AND
REMEDATION PROPOSAL**

COULEE EXPRESS MINI-MART

10 May 1993

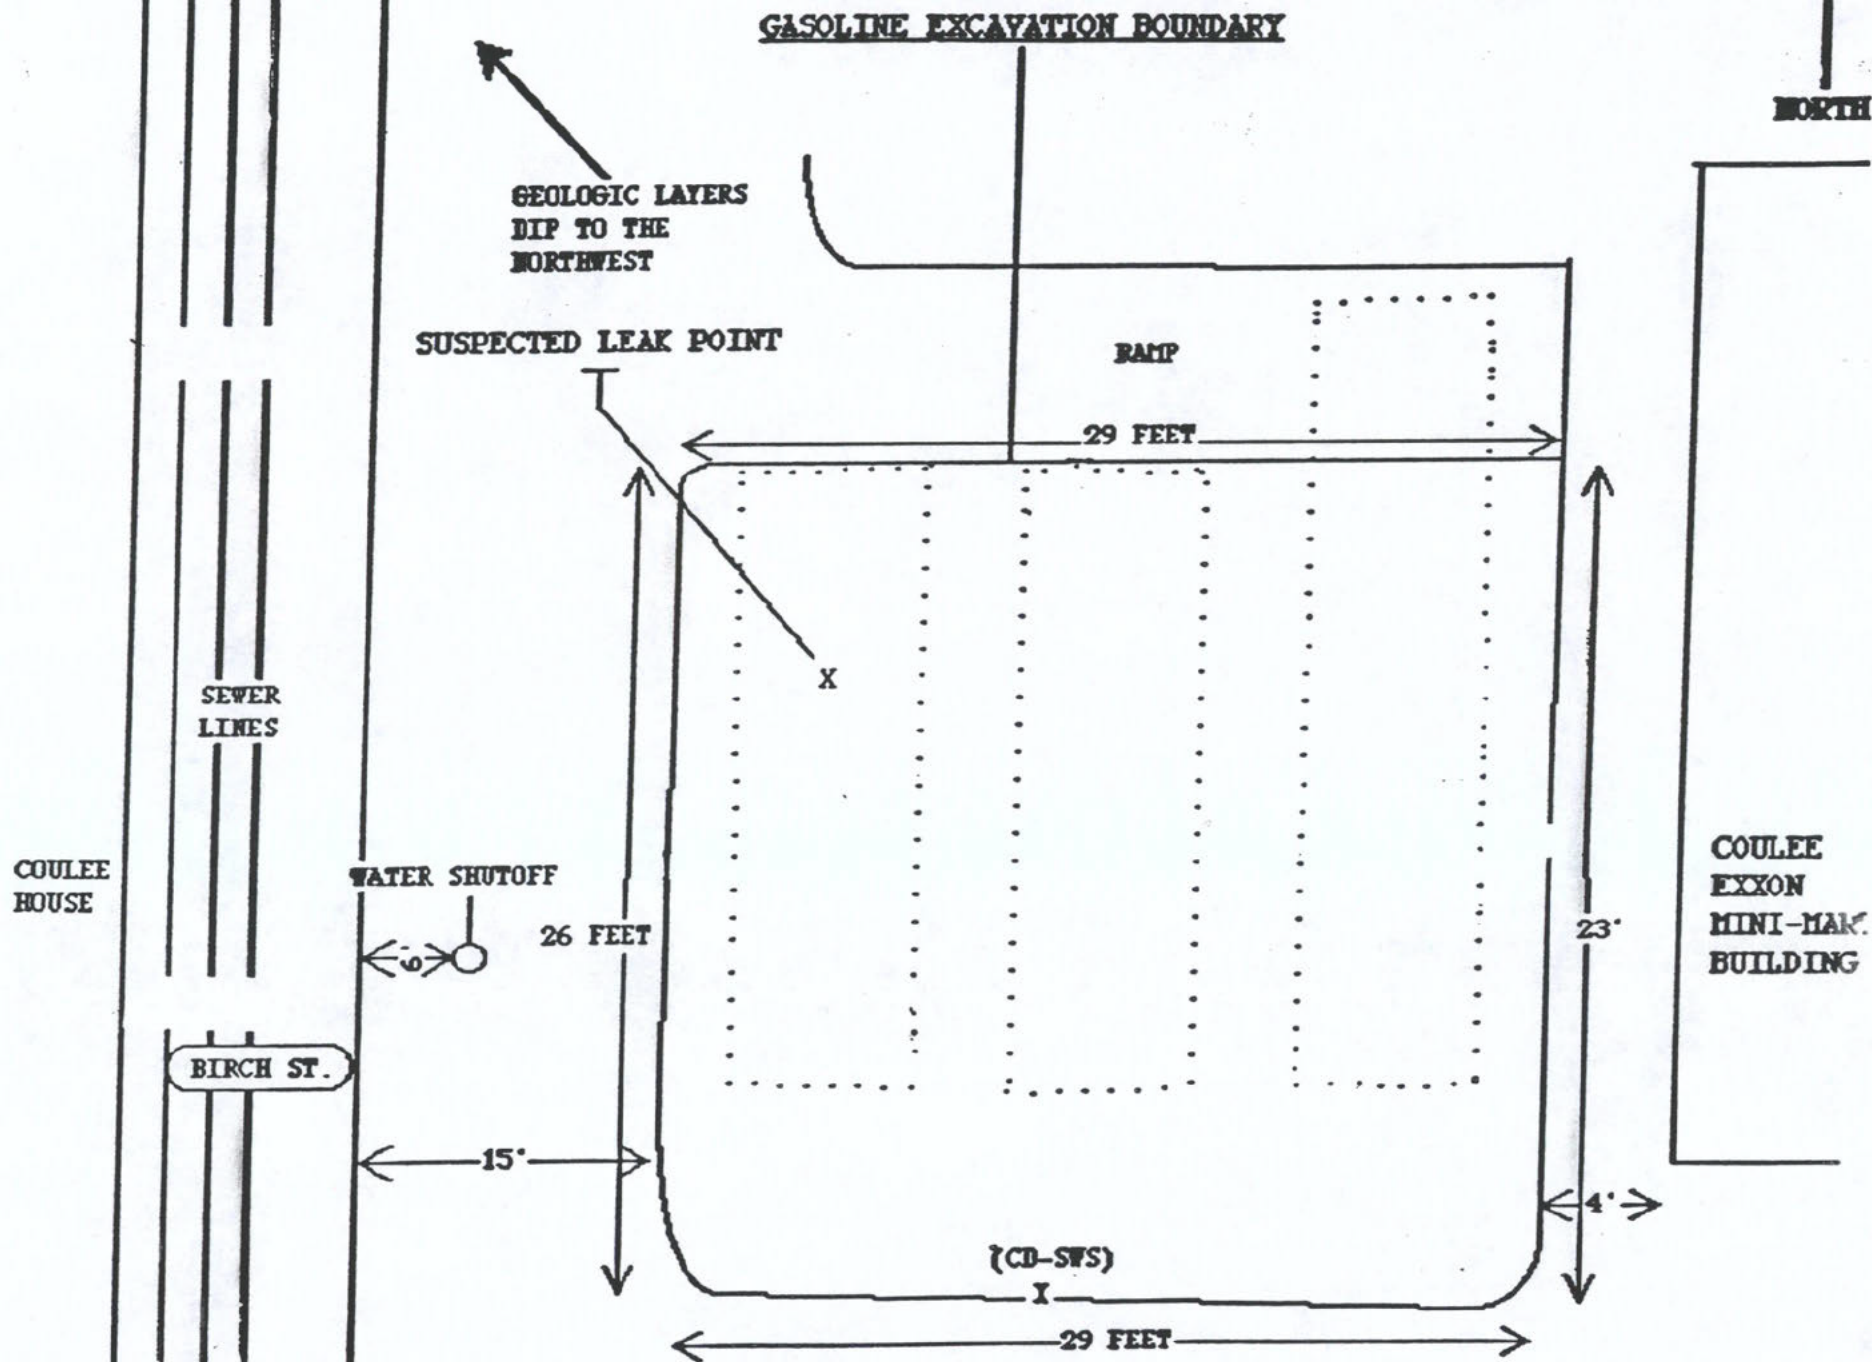
Figure 3: UST Excavation Plans

The excavation pit from the tank removal process had been re-filled with the contaminated soil from the original excavation. This was approved by Robert Cutler of the United States Environmental Protection Agency, Region 10 (see Appendix III). The site slopes gently to the west towards Birch Street.

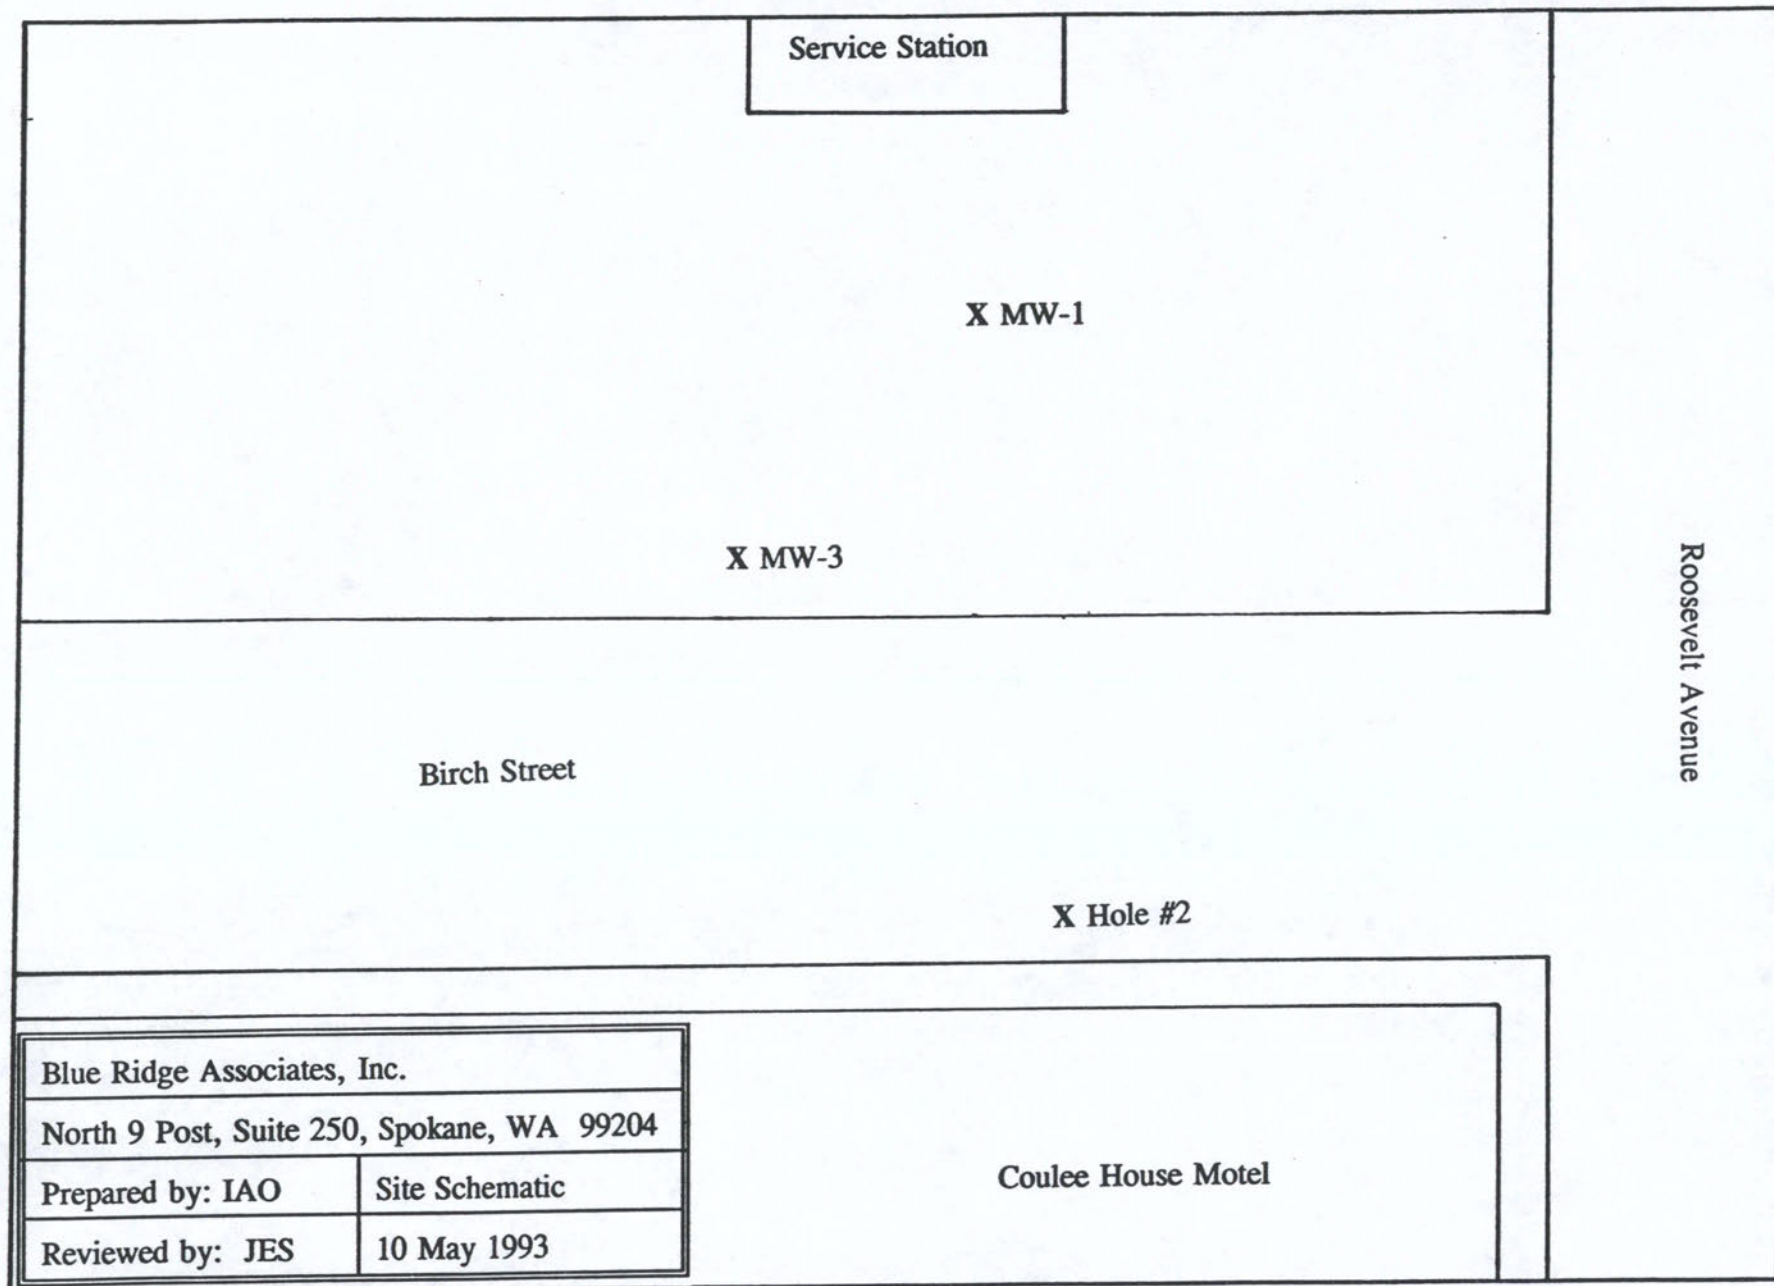
Figure 4: Drilling Locations

Hole number one (Monitoring Well - One (MW-1)) is located in the pit approximately in the same location as the suspected leak point in tank number one, 22.3 feet from the southwest corner of the station and 31.3 feet from the northwest corner of the station (see Figure 4, Drilling Locations). This hole was drilled to a depth of fifty (50) feet and samples were taken at five (5) foot intervals starting at twenty (20) feet below ground surface (BGS). The samples were analyzed using a Photovac Microtip MP-1000 Photoionization Detector (PID). Drilling was stopped at fifty (50) feet BGS as no contamination was detected at this depth. A four (4) inch monitoring well was installed consisting of forty (40) feet of twenty (20)-slot screen, set from ten (10) to forty (40) feet BGS and ten (10) feet of blank PVC set from one half (.5) foot above ground surface to ten (10) feet BGS. Twenty two (22) one hundred (100) pound bags of Colorado Silica Sand (10-20 grade) were placed around the well from fifty (50) feet BGS to seven (7) feet BGS. Two (2) fifty (50) pound bags of bentonite chips (3/4 inch) were placed around the well from seven (7) feet BGS to approximately four (4) feet BGS. The well was not finished to the surface as the intent was to install an underground PVC pipe connecting the well to a vapor extraction system.

Hole number three (Monitoring Well - Two (MW-2)) is located 35.3 feet northwest of MW-1 and 45.3 feet southwest of the northwest corner of the station (see Figure 4). This hole was drilled to a depth of fifty (50) feet and samples were taken at five (5) foot intervals starting at five (5) feet below ground surface (BGS). The samples were analyzed using a Photovac Microtip MP-1000 Photoionization Detector (PID). Drilling was stopped at fifty (50) feet BGS as no contamination was detected in any of the samples. A four (4) inch monitoring well was installed consisting of forty (40) feet of twenty (20)-slot screen, set from ten (10) to forty (40) feet BGS and ten (10) feet of blank PVC set from one half (.5) foot above ground surface to ten (10) feet BGS. Twenty two (22) one hundred (100) pound bags of Colorado Silica Sand (10-20 grade) were placed around the well from fifty (50) feet BGS to seven (7) feet BGS. Four (4) fifty (50) pound bags of bentonite chips (3/4 inch) were placed around the well from seven (7) feet BGS to approximately four (4) feet BGS. The well was not finished to the surface as the intent was to install an underground PVC pipe connecting the well to a vapor extraction system.

The location of hole number one was chosen as it was approximately in the same area as the suspected leak point (see Figure 4). Drilling of this hole was stopped at fifty feet as sample readings obtained with the PID indicated that petroleum levels were dropping from thirty-five (35) feet BGS and at fifty (50) feet BGS no petroleum contamination was indicated when analyzing the sample with the PID.

The location of hole number three was chosen as it was down-dip from the suspected leak point (see Figure 4). Although no petroleum contamination was detected in any of the ten (10) samples obtained from this hole, drilling continued to a depth of fifty (50) feet in order to install a monitoring well to be used for later remediation.

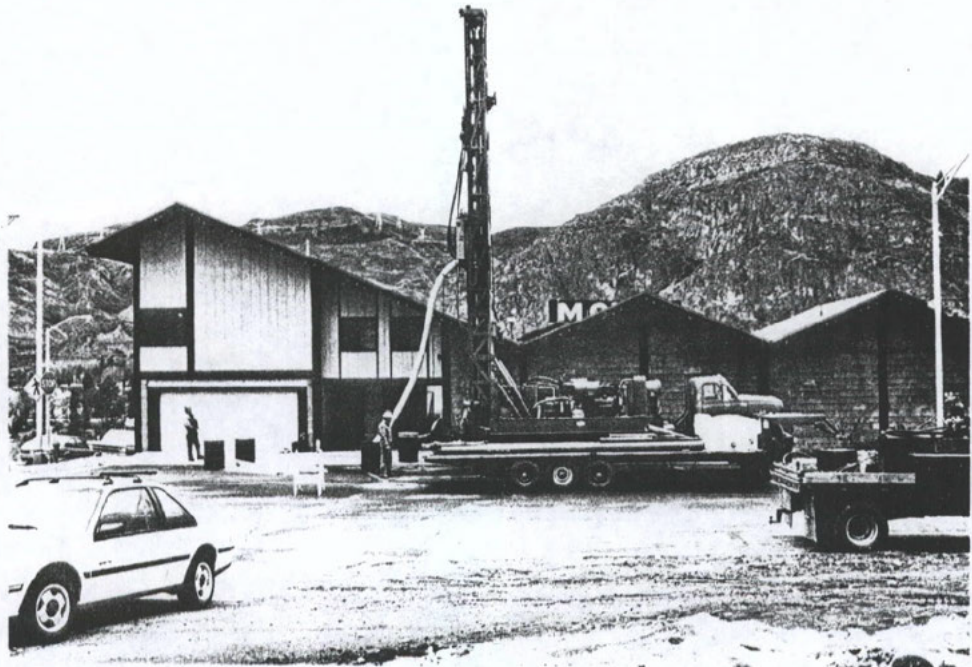
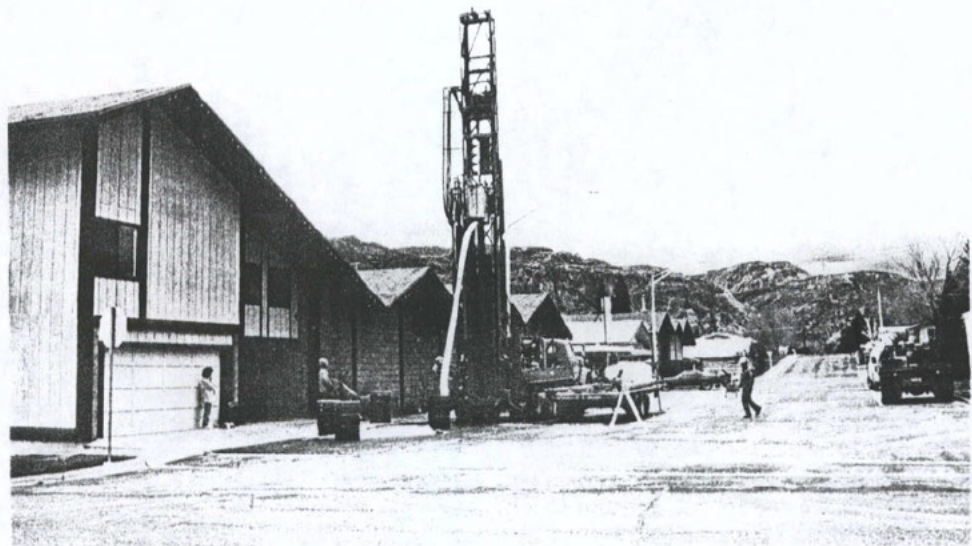
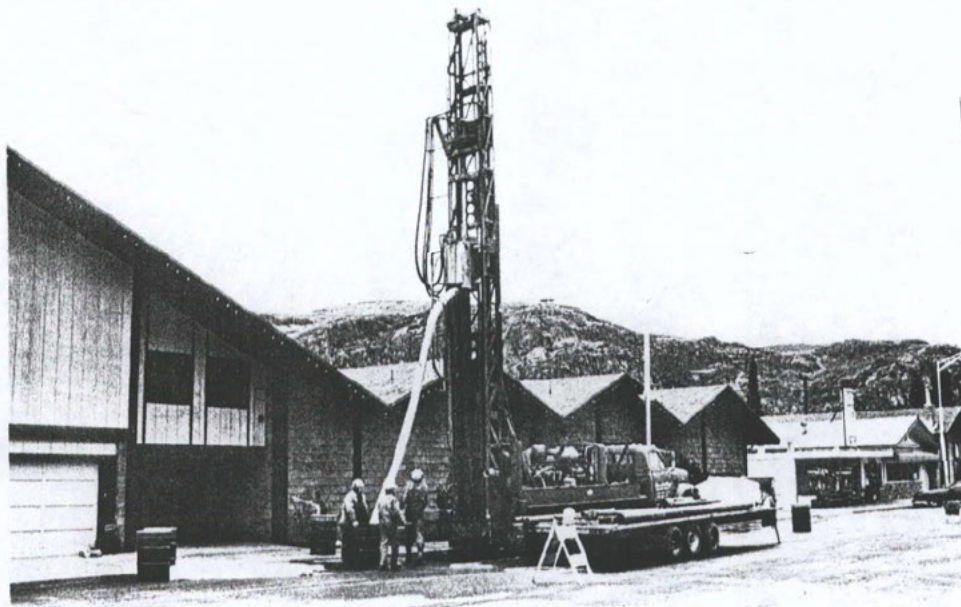
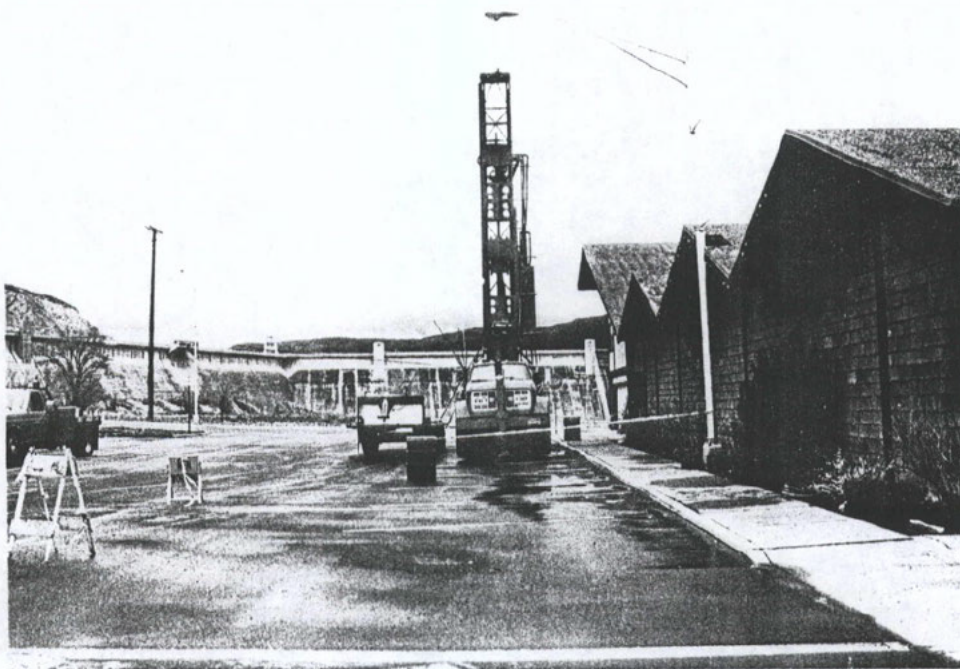
Hole number two was located across Birch Street, approximately five (5) feet from the sidewalk by the Coulee House Motel (see Photographs 5-8). The hole was drilled to a depth of thirty (30) feet and abandoned as no petroleum based contamination was detected using the PID. The well was abandoned according to State of Washington Department of Ecology Minimum Standards for Construction and Maintenance of Wells: Chapter 173-160-420 WAC, May 5, 1988. The hole was filled to the surface with twenty-four (24) fifty (50) pound bags of bentonite.

Drilling of hole number two was stopped at thirty feet as no contamination was detected in any of the samples. The hole was located across Birch Street, approximately five (5) feet from the sidewalk by the Coulee House Motel (see Figure 4; and Photographs 5-8). This location was chosen as (b) (6) of the Coulee House Motel had reported a strong petroleum odor in his basement office. As no contamination was detected in any of the six (6) samples it is believed that petroleum vapors traveled along the water line from the Mini Mart to the water main located in the center of Birch Street and then along the water line to the Coulee House Motel. (b) (6) stated that the petroleum odor disappeared once the tanks had been cleaned and removed.
